## ACACIA MINING OPERATIONS - GÖKIRMAK COPPER PROJECT

# Risk Assessment for the Kepezkaya Tailings Storage Facility

**Submitted to:**  
Acacia Mining Operations

**Report Number** 1668788 Kepezkaya TSF  
Risk Assessment A.1

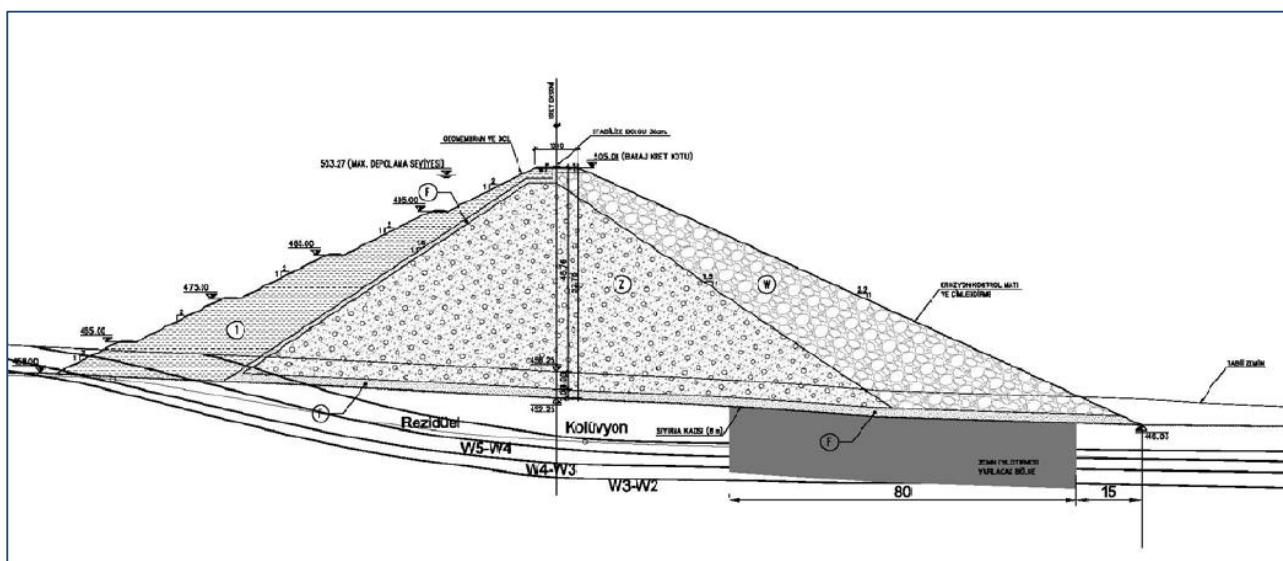
**Figure 3-1 Section through the Embankment Wall**

The Kepezkaya TSF to be constructed to full height before commissioning and will have a maximum height of approximately 53 m from its foundation. The upstream slope is benched with 2H:1V inter bench slopes and a bench width of approximately 4 m (at 10 m intervals down from the crest) resulting in an overall slope of approximately 2.4H:1V. The downstream slope is designed at 2.2H:1V.

The main embankment will be constructed from rockfill with a central interface drainage layer and a clay wedge on the upstream side, where the facility will be equipped with a composite liner.

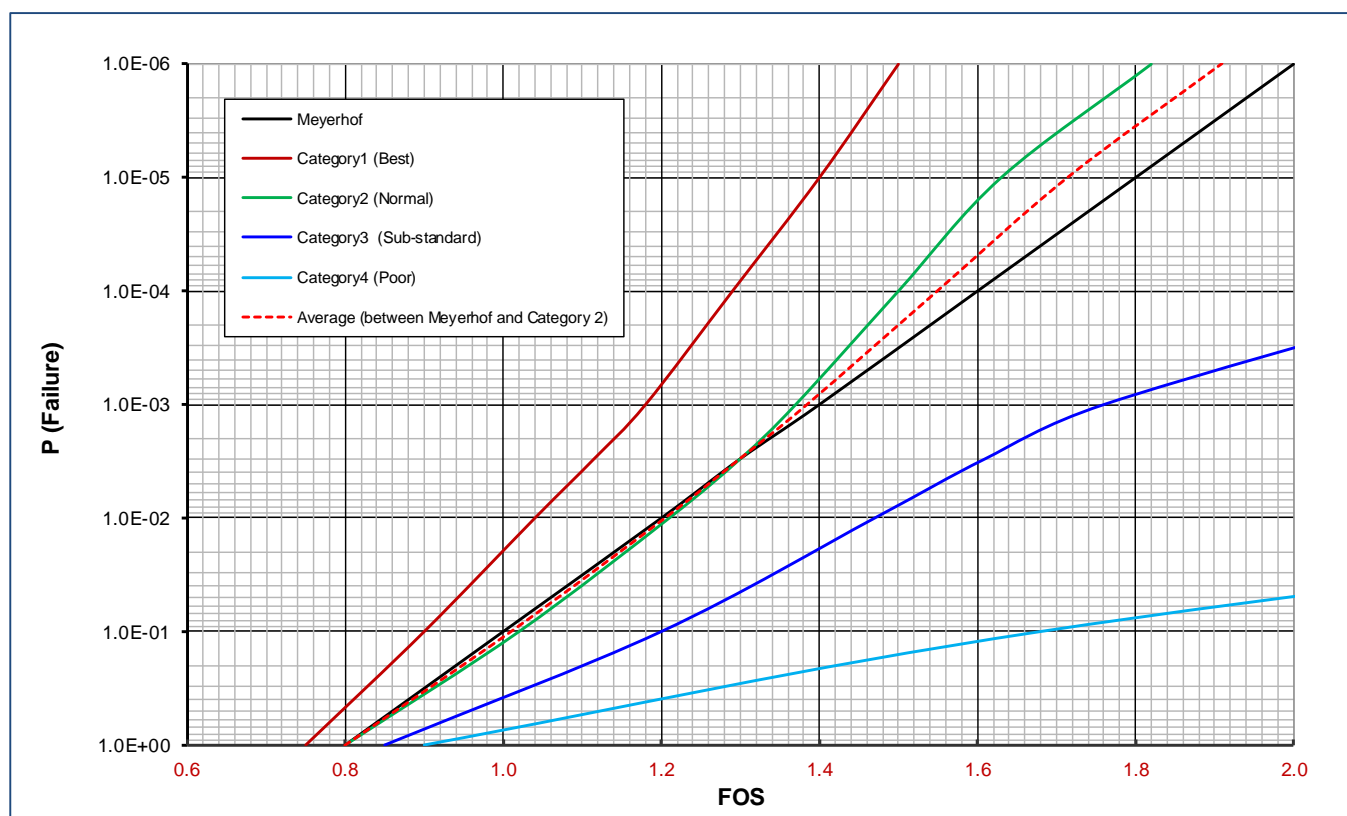
**Figure 6-1: Relationship between Factor of Safety and Probability of Failure (after Silva et al and Meyerhof)**

The Factors of Safety calculated by the designers for the outer slope of the TSF were converted to annual Probabilities of Failure using a relationship proposed by Silva et al (Reference 6.5), 1998 and Meyerhof (Reference 6.6), 1970. Probabilities for other modes of failure which may lead to a slope failure were based (where deemed relevant) on data extracted from the ICOLD bulletins, and was used in the overall assessment of risk of slope instability.

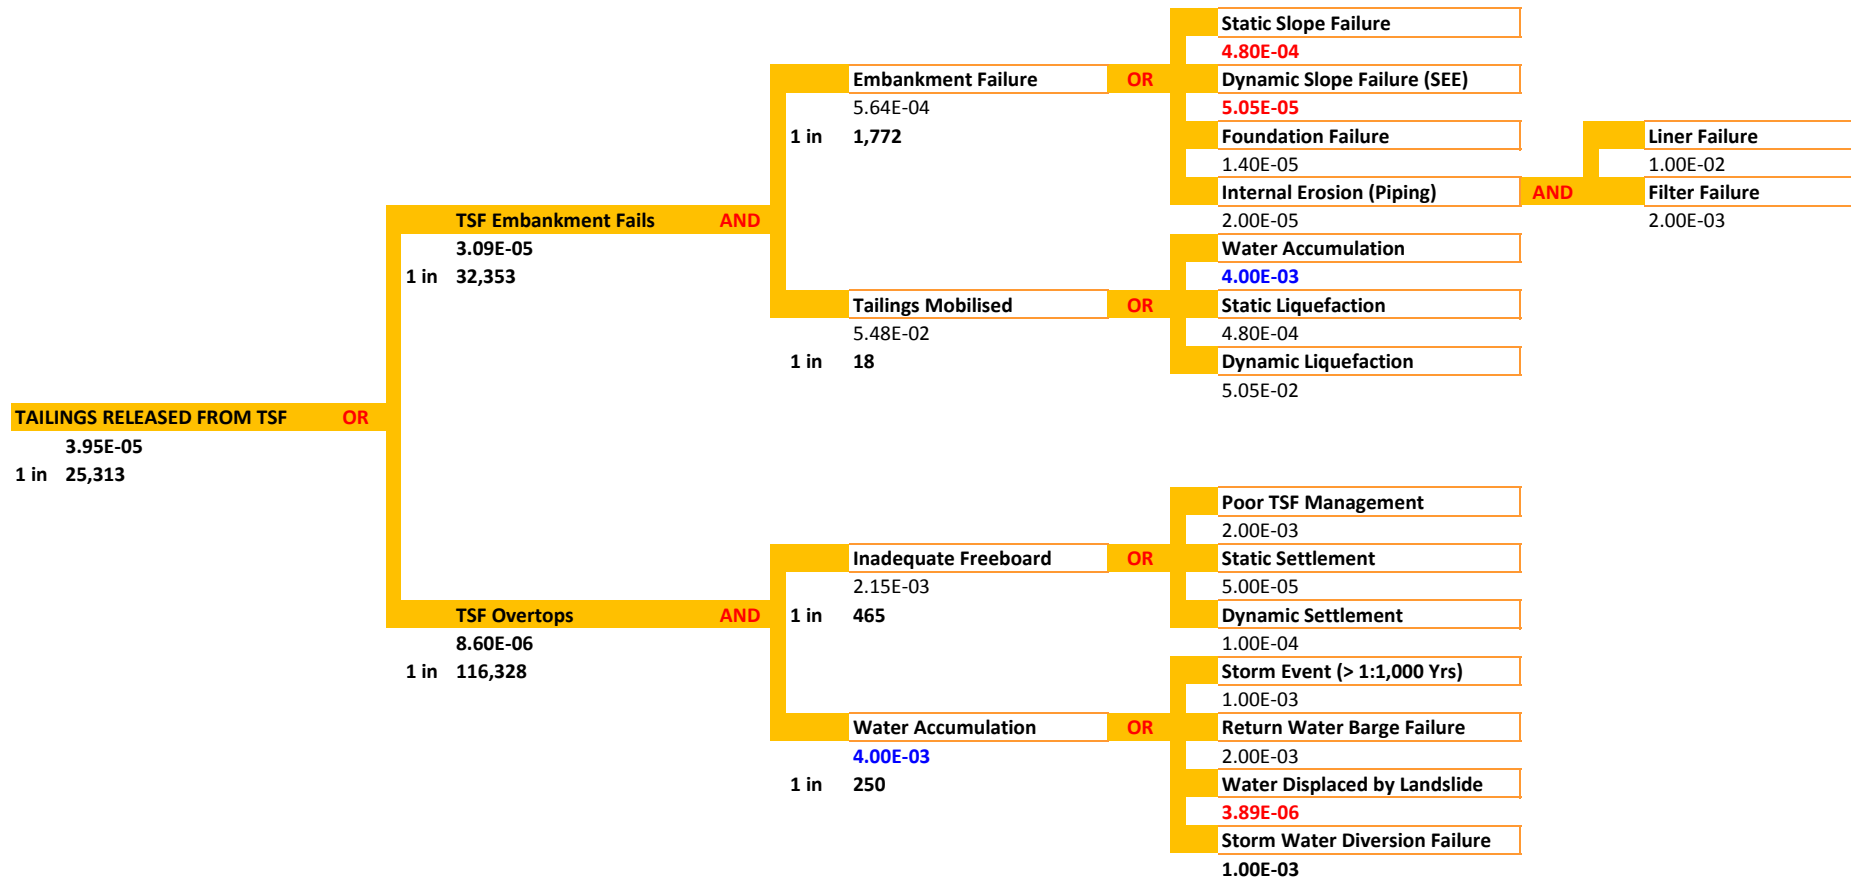
ACACIA MINING - KEPEZKAYA TSF  
OPERATING PHASE

ICOLD AVERAGE ANNUAL POF ~ 1 in 6061

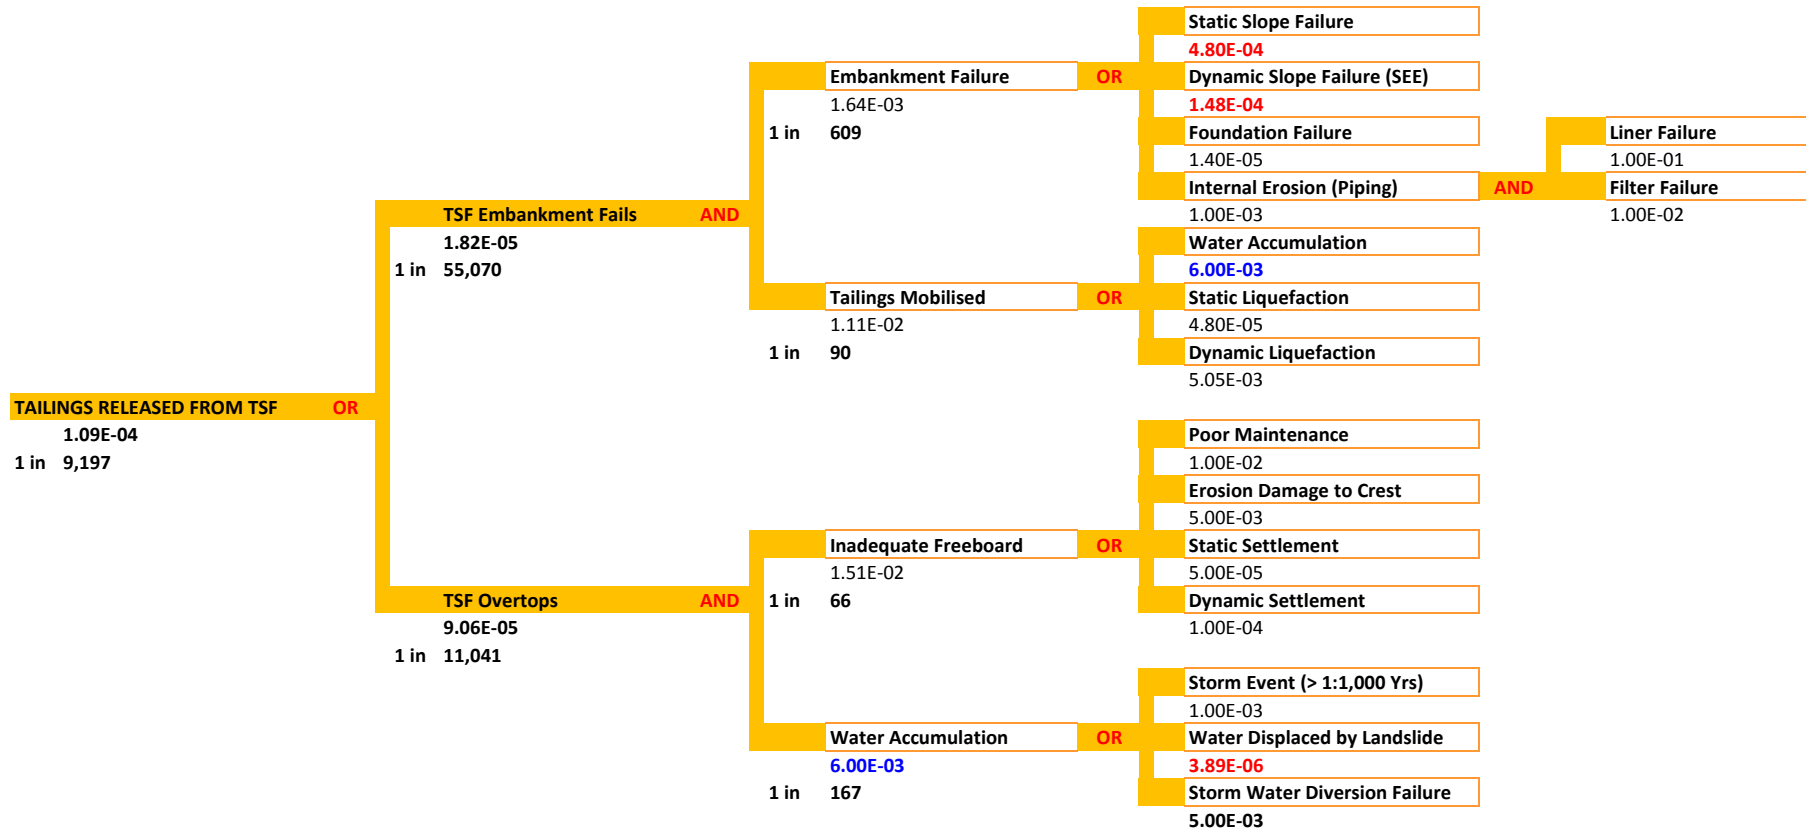
ACACIA MINING - KEPEZKAYA TSF  
IMMEDIATELY POST CLOSURE PRIOR TO CAPPING

ICOLD AVERAGE ANNUAL POF ~ 1 in 6061

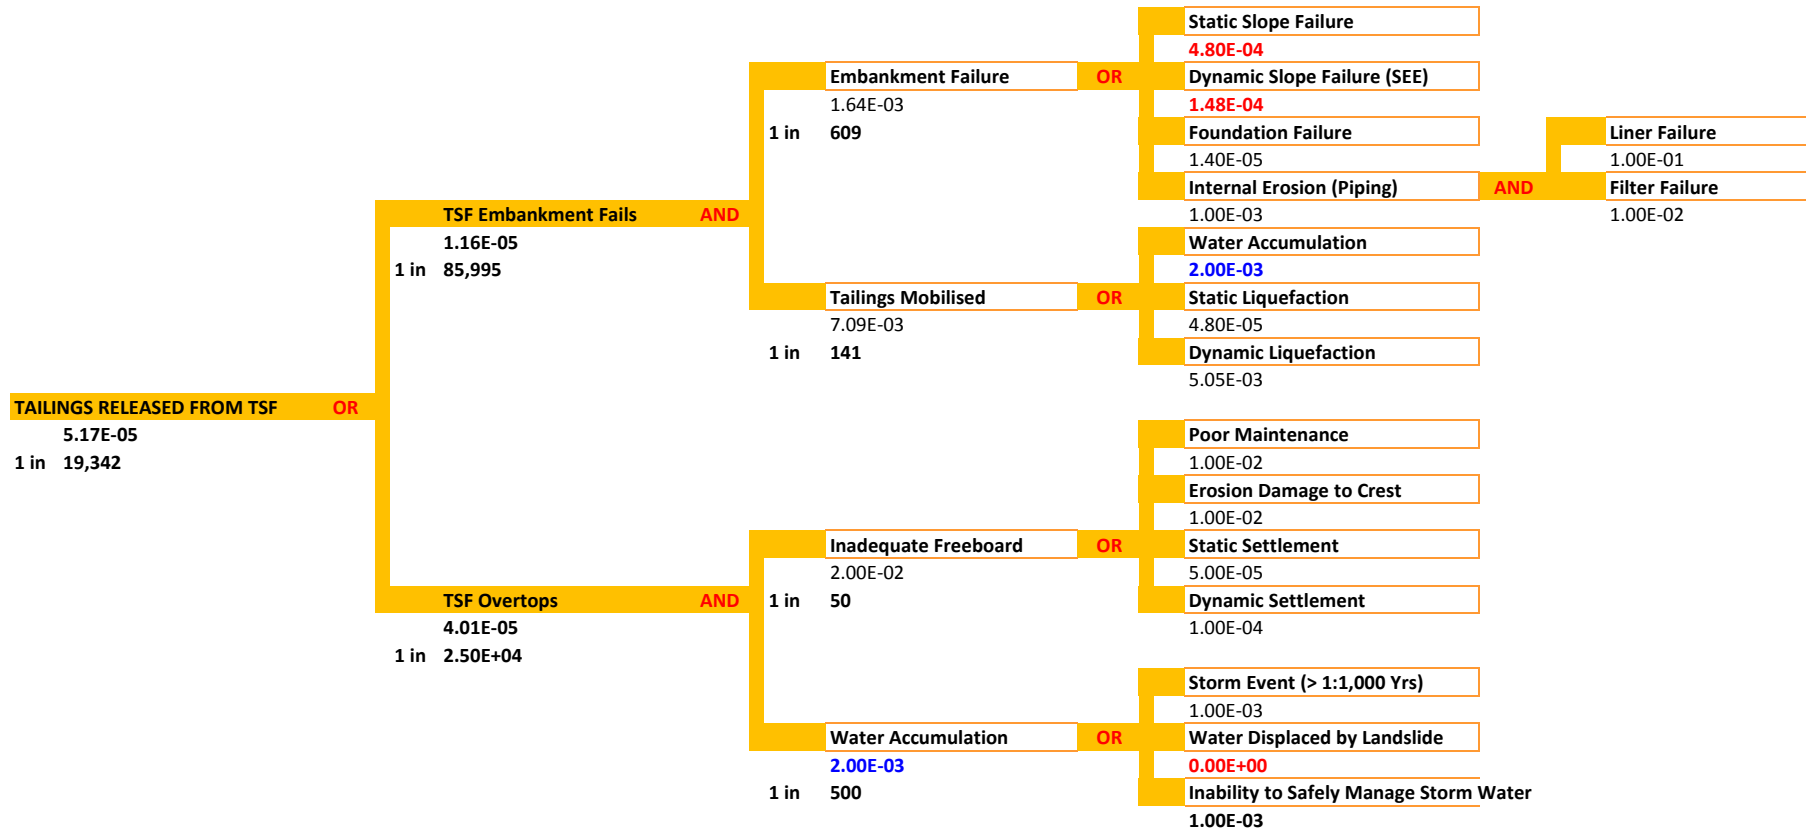
ACACIA MINING - KEPEZKAYA TSF  
POST CLOSURE AFTER CAPPING

ICOLD AVERAGE ANNUAL POF ~ 1 in 6061

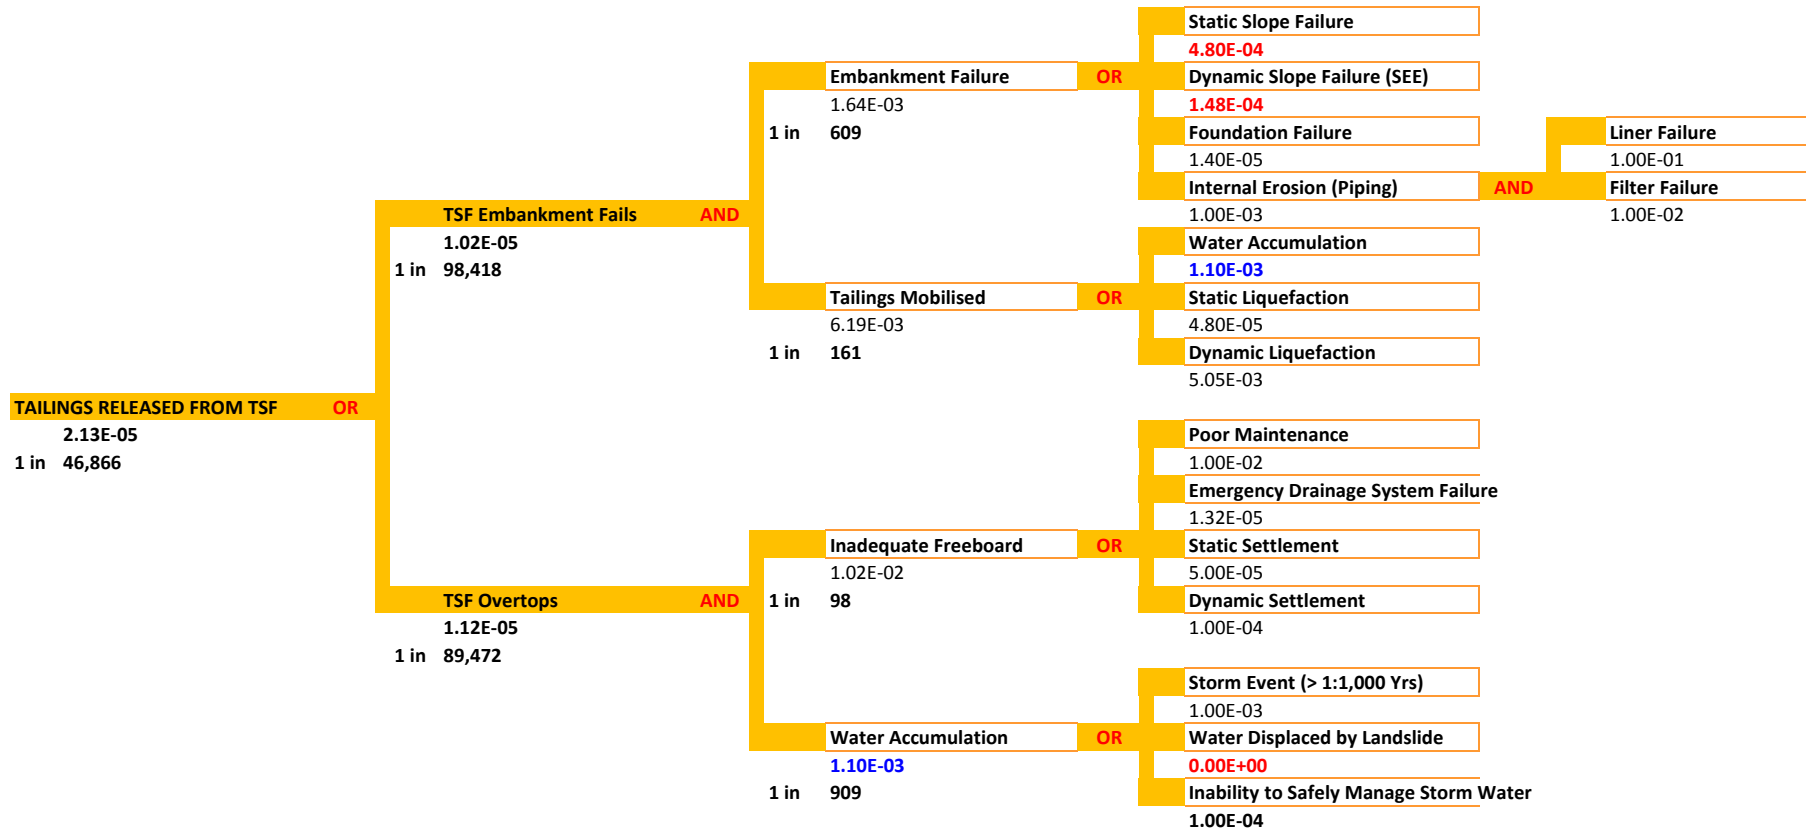
ACACIA MINING - KEPEZKAYA TSF  
POST CLOSURE AFTER CAPPING WITH EMERGENCY DRAINAGE SYSTEM

ICOLD AVERAGE ANNUAL POF ~ 1 in 6061
