**Kazakhstan: Beineu-Bozoy-Saksaulsk Roads:  
PROJECT FEASIBILITY ASSESSMENT  
PR 017140  
Road Safety Audit Report**

October 2026

| REPORT TITLE | Road Safety Audit Report |

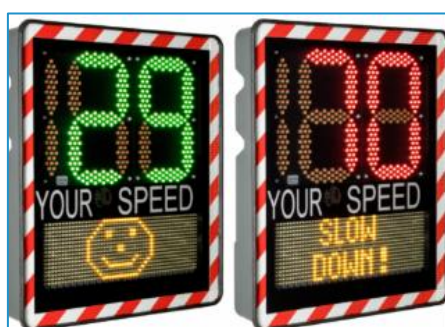
**Figure 12 - Example of radar speed signs**

A speed enforcement strategy should be incorporated into the detailed design, including the installation of radar speed display signs at crucial locations to inform drivers of their actual speed and reinforce compliance with the posted limits, thereby reducing the likelihood of speed-related collisions. In addition, speed-limit signs should be provided at appropriate intervals, particularly on approaches to curves, junctions and other high-risk sections, to ensure that drivers are adequately informed of the applicable speed limit and any changes in speed restrictions.

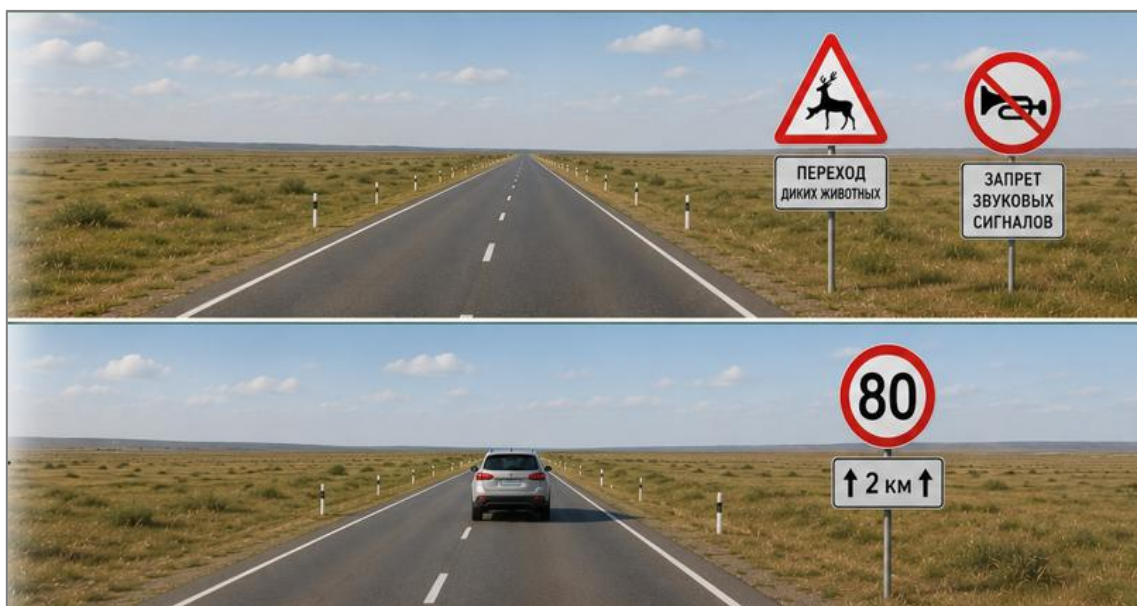
**Figure 25: Wildlife crossing warning signage and 80 km/h speed limit**

During the detailed design, review the speed-management strategy at locations with a significant potential for wildlife presence or crossing. Consider whether a lower speed limit, potentially 60 km/h at the highest-risk locations, is warranted based on the characteristics of each site, wildlife movement patterns, the extent of identified migration zones, visibility, fencing and crossing arrangements. In addition, verify that an appropriate wildlife-mitigation strategy is developed, including updated route migration maps, exclusion fencing, escape measures, wildlife guidance systems, and monitoring provisions where required, to maximise the effectiveness of crossing structures and minimise wildlife-vehicle collisions.
