Biodiversity Impact Assessment

460.8 MW Vifor Wind Farm Buzău County, Romania

Project No.: 0667256

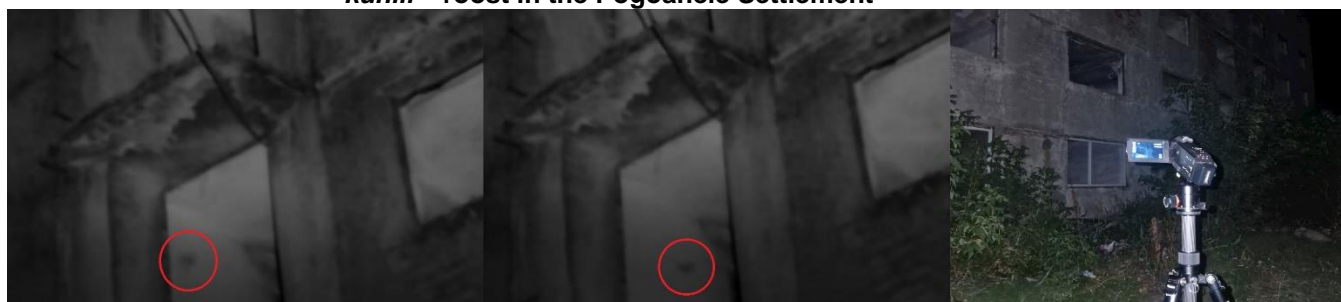
Figure 4-16 Infrared camera monitoring – example of flight path of re-entry for *Pipistrellus kuhlii* – roost in the Pogoanele Settlement
