Kelme Wind Farm, Lithuania

Habitat Residual Impact Assessment

0779257

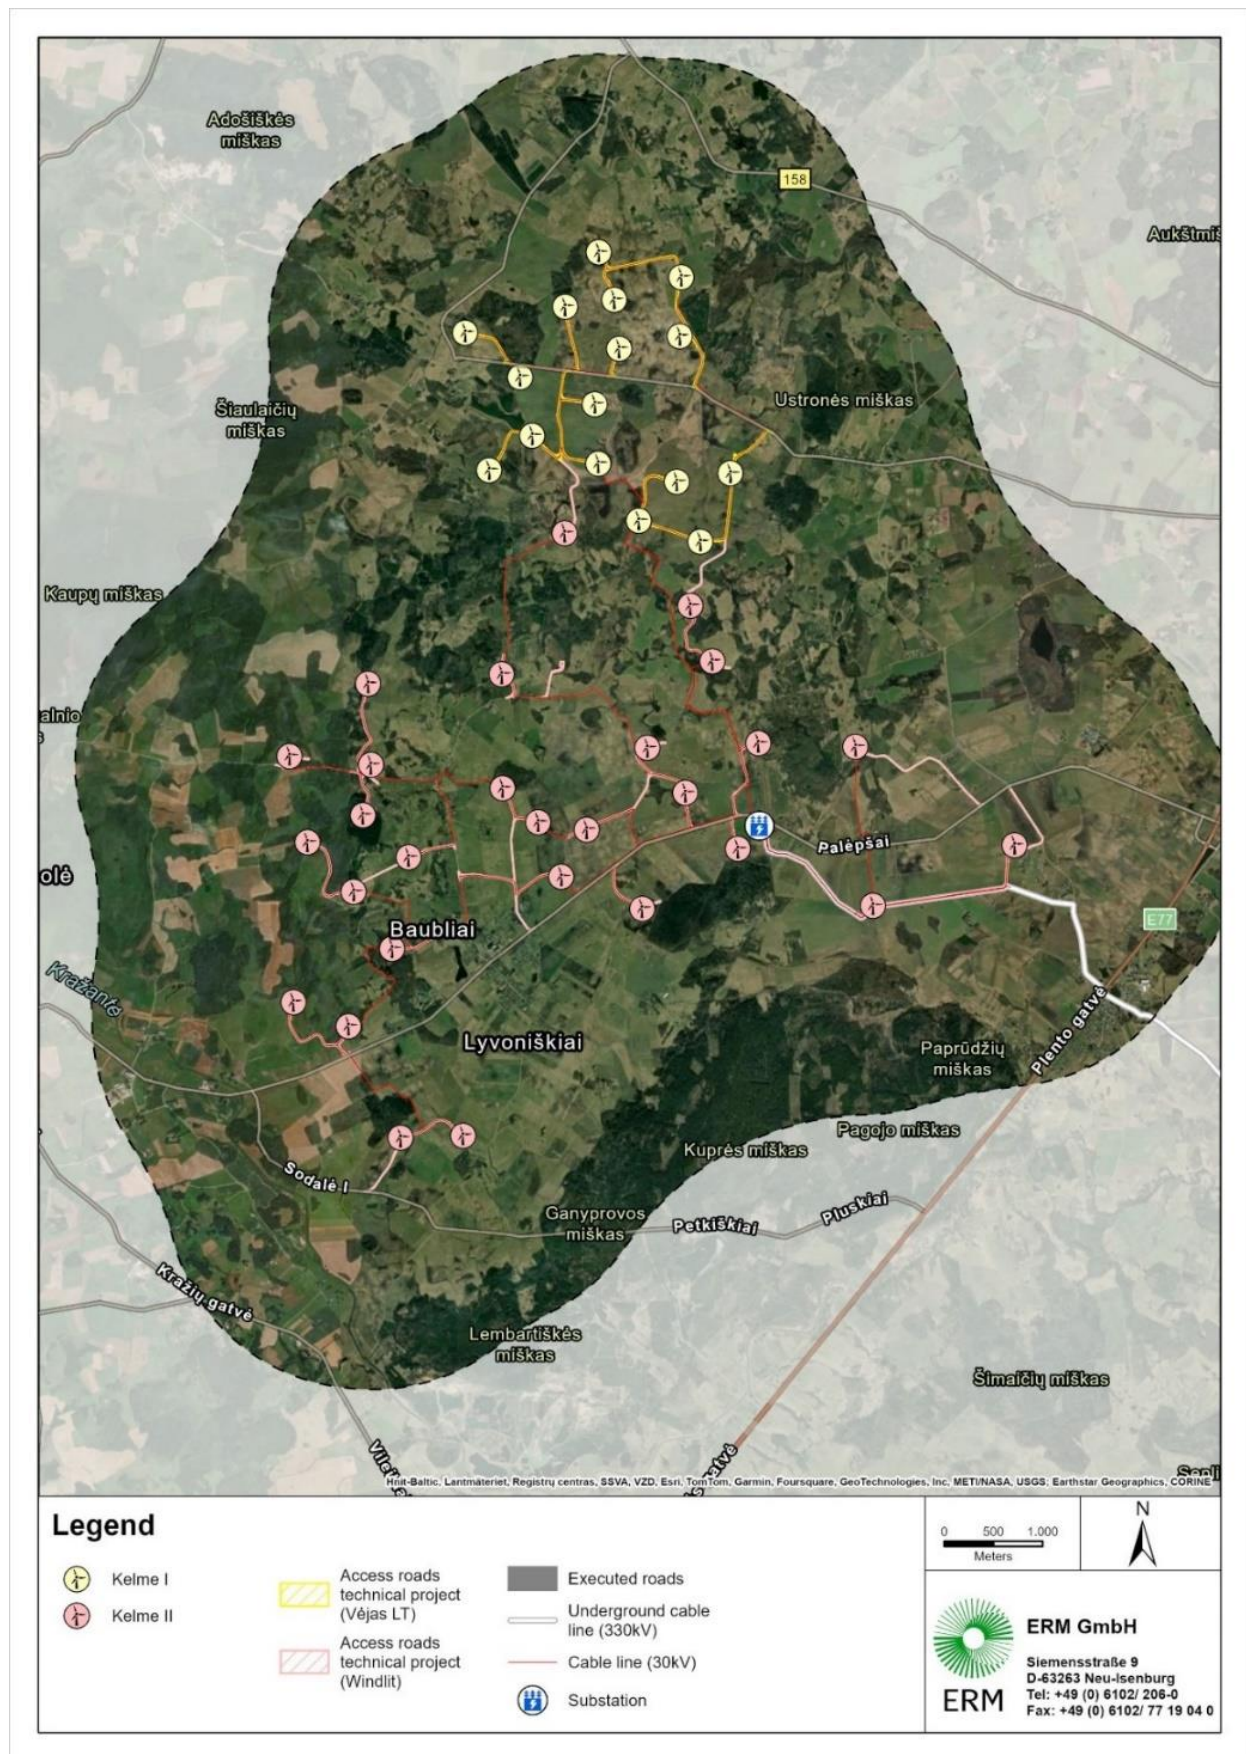
FIGURE 1-1 PROJECT LAYOUT MAP FOR KELME I AND II

The Kelme Wind Farm Project (referred to hereafter as "the Project") located in Lithuania comprises two sub-projects, Kelme I and Kelme II, with a power generation capacity of 105 MW and 195 MW, respectively. Kelme I includes 16 wind turbines ("WTs"), whilst Kelme II includes 28 WTs. The Project also includes a 28.8 km underground transmission line to enable the connection of both wind farms to the electrical grid. The Project layout is shown on the map in Figure 1-1.
