# Kelme Wind Farm, Lithuania

## Habitat Residual Impact Assessment

Ignitis Renewables

DATE  
10 July 2025

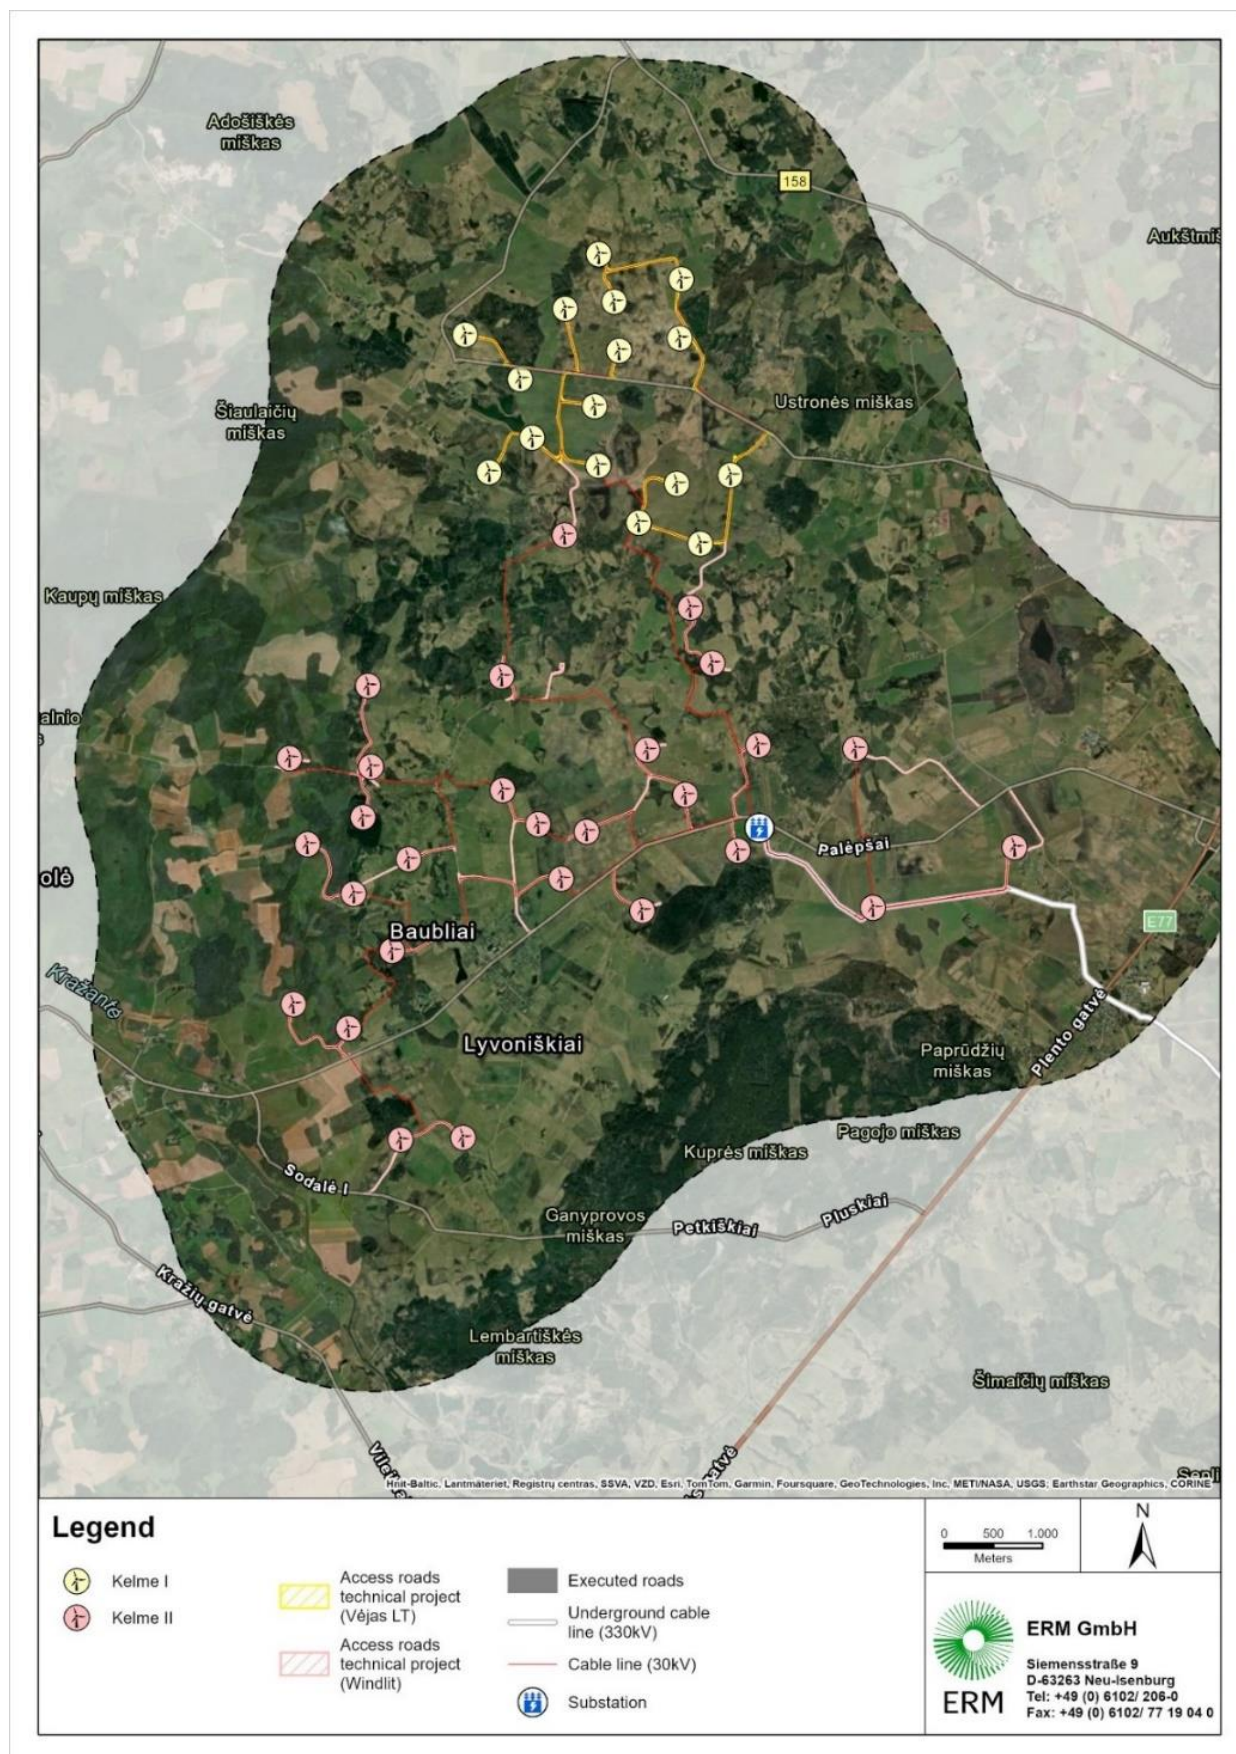
FIGURE 1-1 PROJECT LAYOUT MAP FOR KELME I AND II

Source: ERM, based on data provided by Ignitis

The Kelme Wind Farm Project (referred to hereafter as "the Project") located in Lithuania comprises two sub-projects, Kelme I and Kelme II, with a power generation capacity of 105 MW and 195 MW, respectively. Kelme I includes 16 wind turbines ("WTs"), whilst Kelme II includes 28 WTs. The Project also includes a 28.8 km underground transmission line to enable the connection of both wind farms to the electrical grid. The Project layout is shown on the map in Figure 1-1.

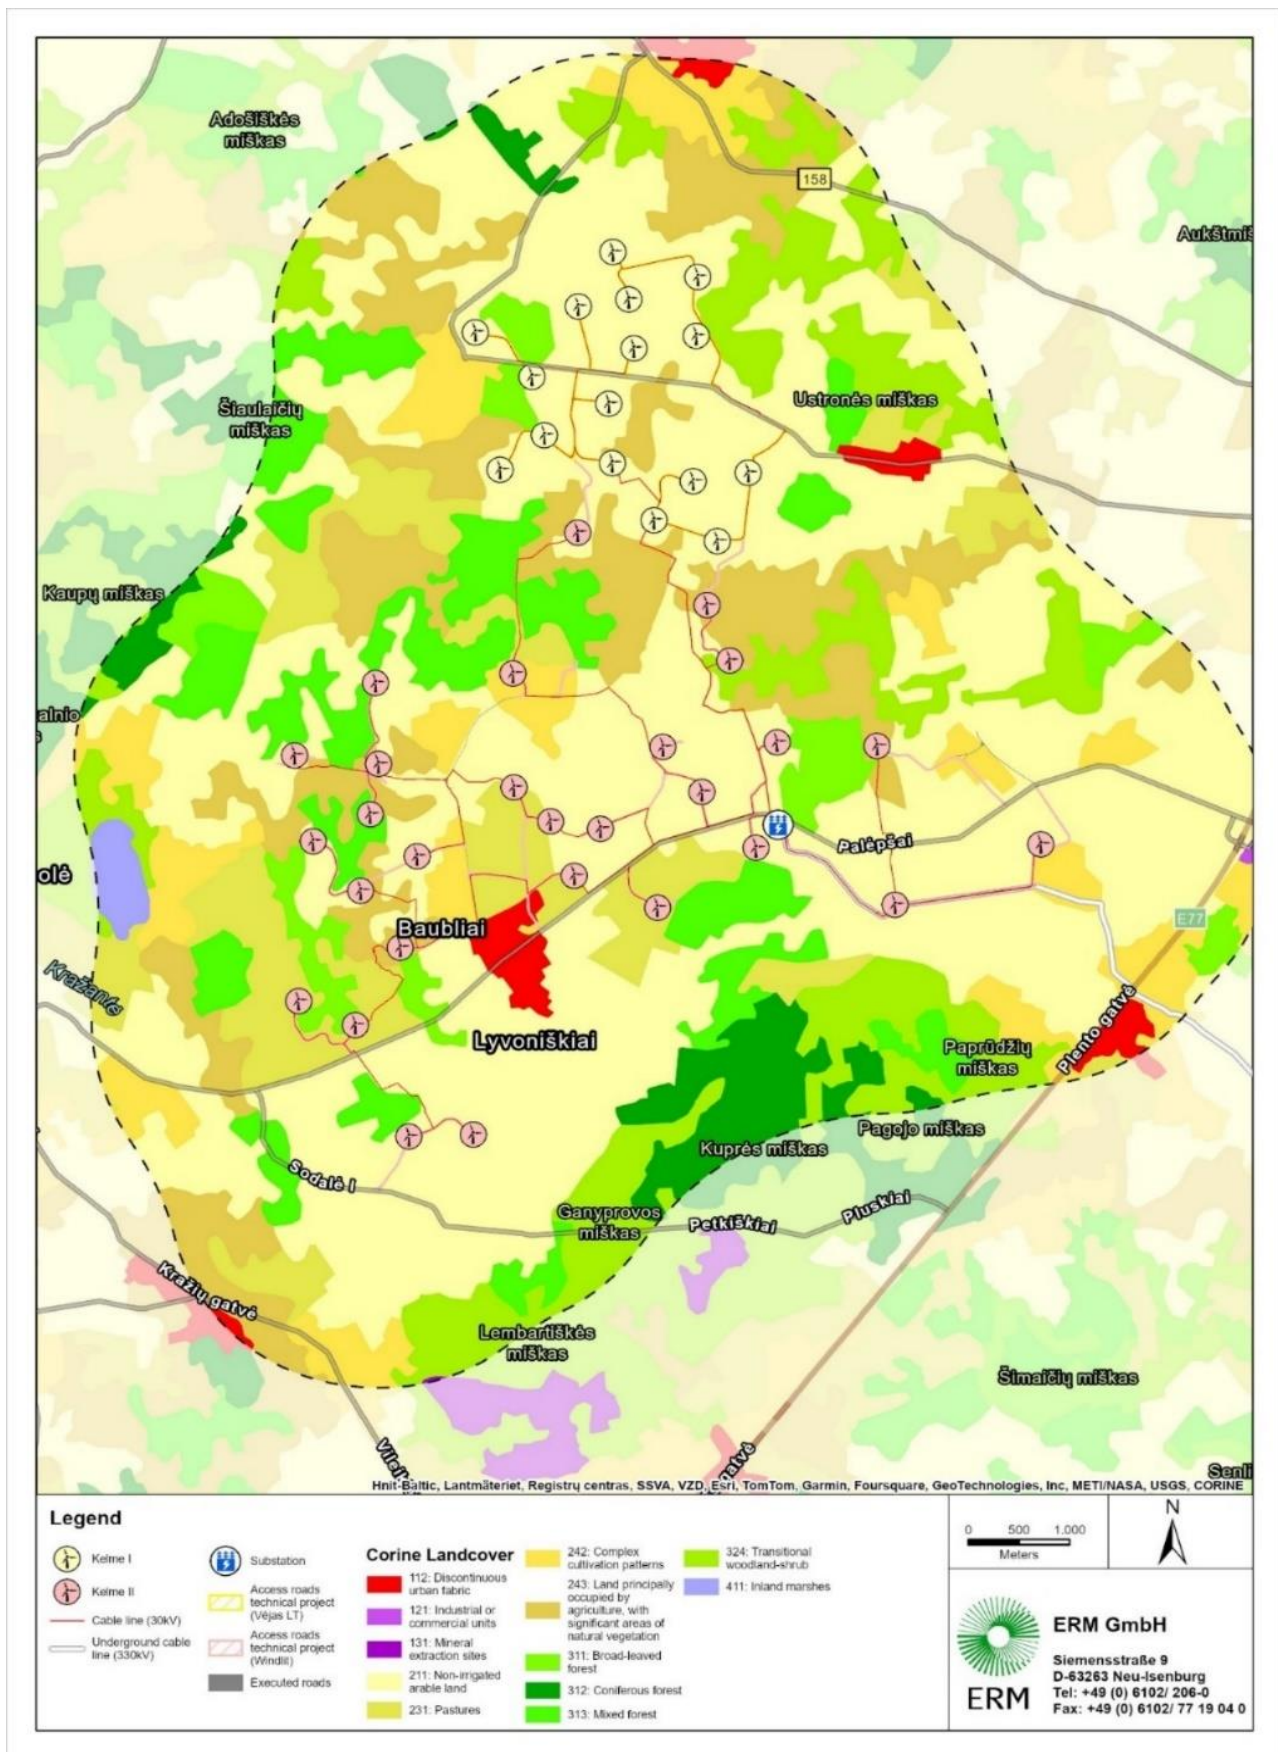
FIGURE 2-1 CORINE LAND COVER MAP WITH PROJECT LAYOUT OVERLAY

Source: ERM, based on data provided by Ignitis, CORINE land cover dataset (Copernicus, 2018)

A desktop level assessment using GIS (Geographical Information Systems, QGIS) was first undertaken by ERM to determine the location of focal areas of habitats as these relate to forest, riverine vegetation and wetlands crossed by the Project infrastructure based on the latest layout plan and spatial data provided by Ignitis (showing location and extent of access roads/upgrades, undergrounds transmission line alignment, turbine and pad locations and extent. Initially, the spatial data showing access roads, turbines, pads, transmission lines was overlaid onto a global land cover map (CORINE land cover), as indicated on the map in Figure 2-1. Intersections of infrastructure for the Project with the land cover types related to natural habitat types were plotted in GIS (i.e. broad-leaved and mixed forest types, inland wetlands/marshes and transitional woodland).

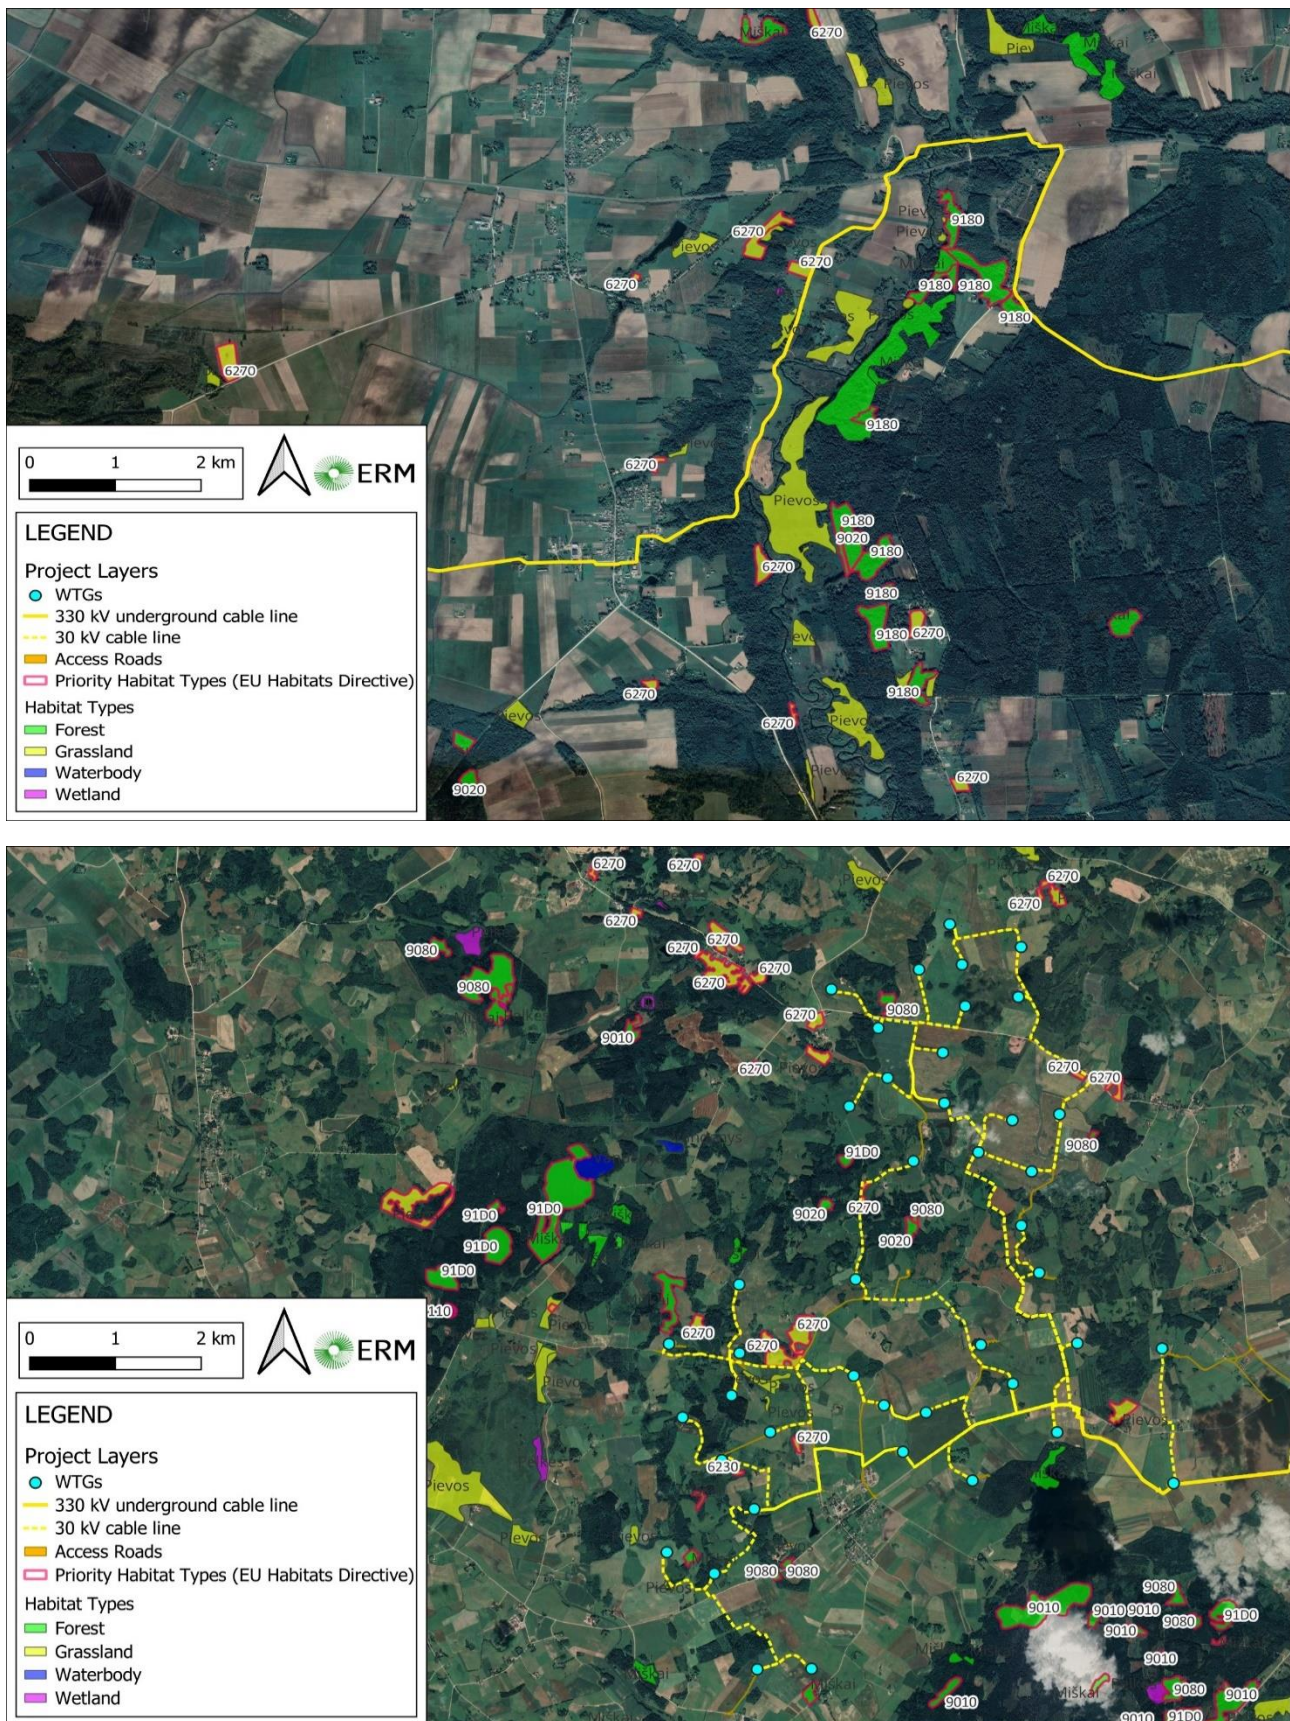
**FIGURE 2-2 ANNEX I HABITAT TYPES IN RELATION TO THE PROJECT (ABOVE FOR THE TL, BELOW FOR WF)**

Source: ERM, based on data provided by Ignitis, Lithuanian Geoportal.lt database online at:  
<https://www.geoportal.lt/map/>

Finally, a review of satellite imagery (Google Earth™) in relation to the Project layout was undertaken in GIS by an experienced remote-sensing operator with extensive experience in identifying and classifying habitats using satellite imagery. This manual process was useful in identifying additional areas potentially impacted at a scale/resolution not covered by the global/regional habitat datasets used.

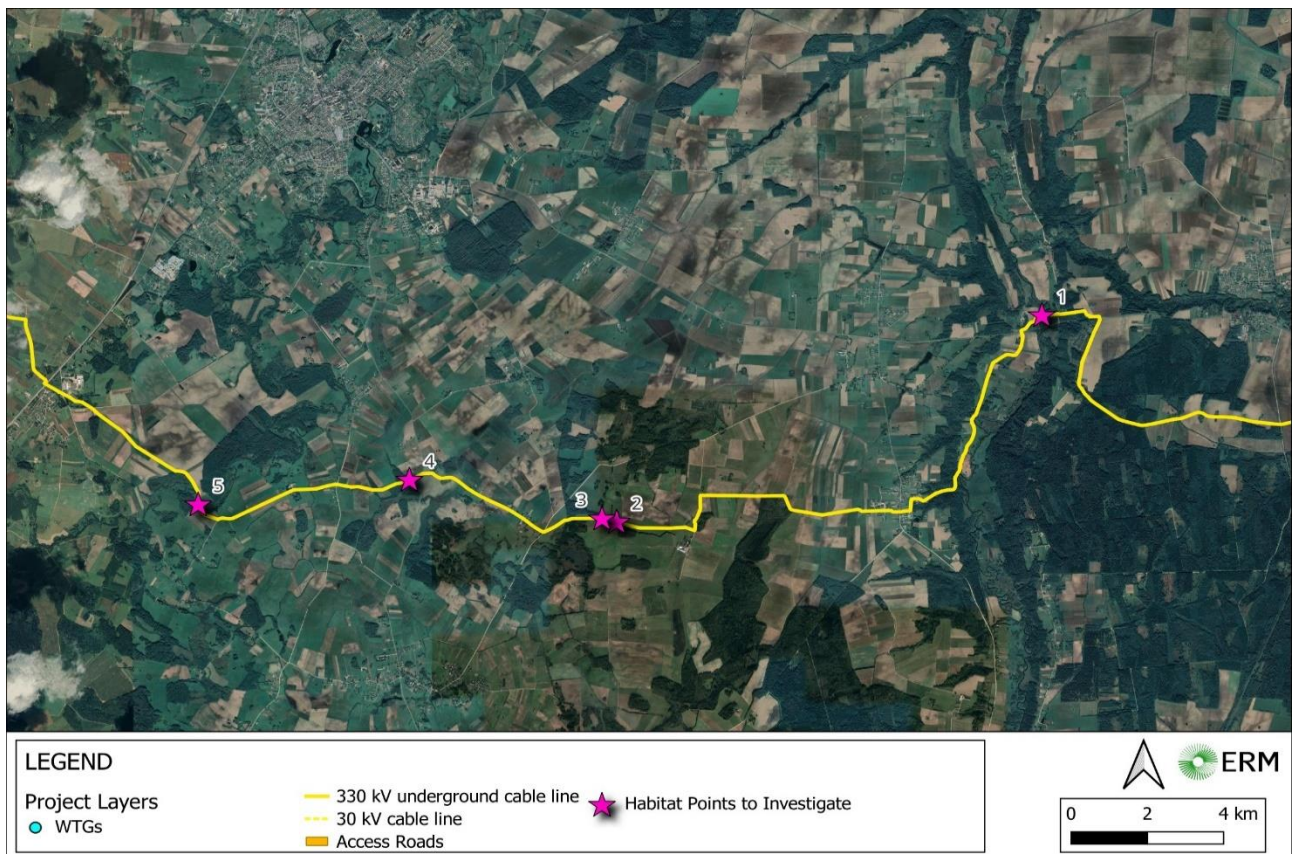
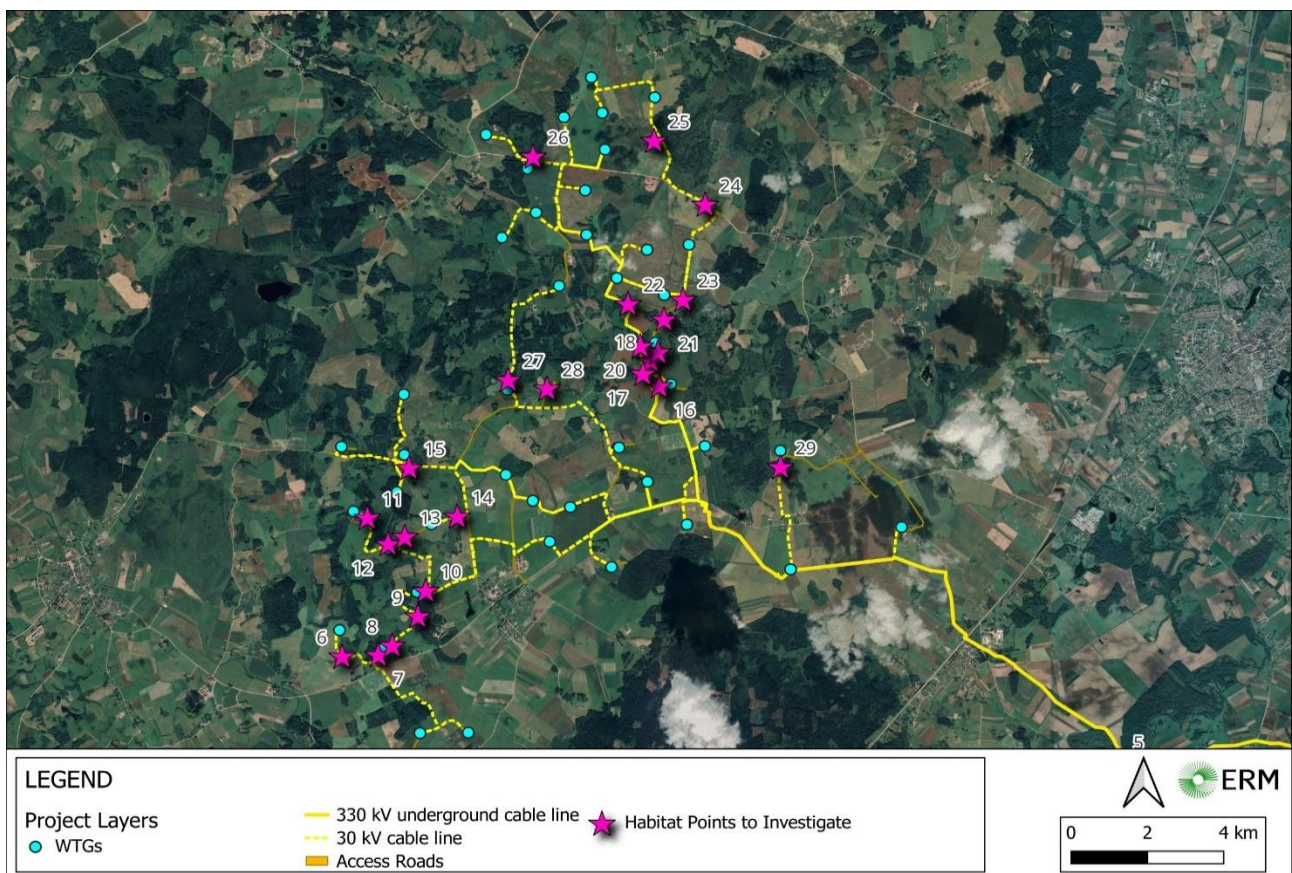
**FIGURE 3-1 MAP SHOWING THE LOCATION OF FOCAL SITES IDENTIFIED FOR FIELD SURVEYS OF HABITATS (ABOVE FOR THE TL, BELOW FOR THE WF)**

Source: ERM, based on data provided by Ignitis

The GIS analysis undertaken as per the approach and methods in Chapter 2 identified a total of 29 focal areas for field verification of habitats where potential residual impacts of Project infrastructure construction to natural habitats are predicted to have possibly occurred.

These are indicated on the map in Figure 3-1.

Field surveys were undertaken at each of the focal points requiring investigation (indicated in section 3.1 and the map in Figure 3-1).
